DEVELOPMENT OF AN INTEGRATED CATCHMENT MANAGEMENT PLAN FOR Pyeng, PLATEAU STATE

Kehinde Ogunmola, PhD

NCRS CONSULT

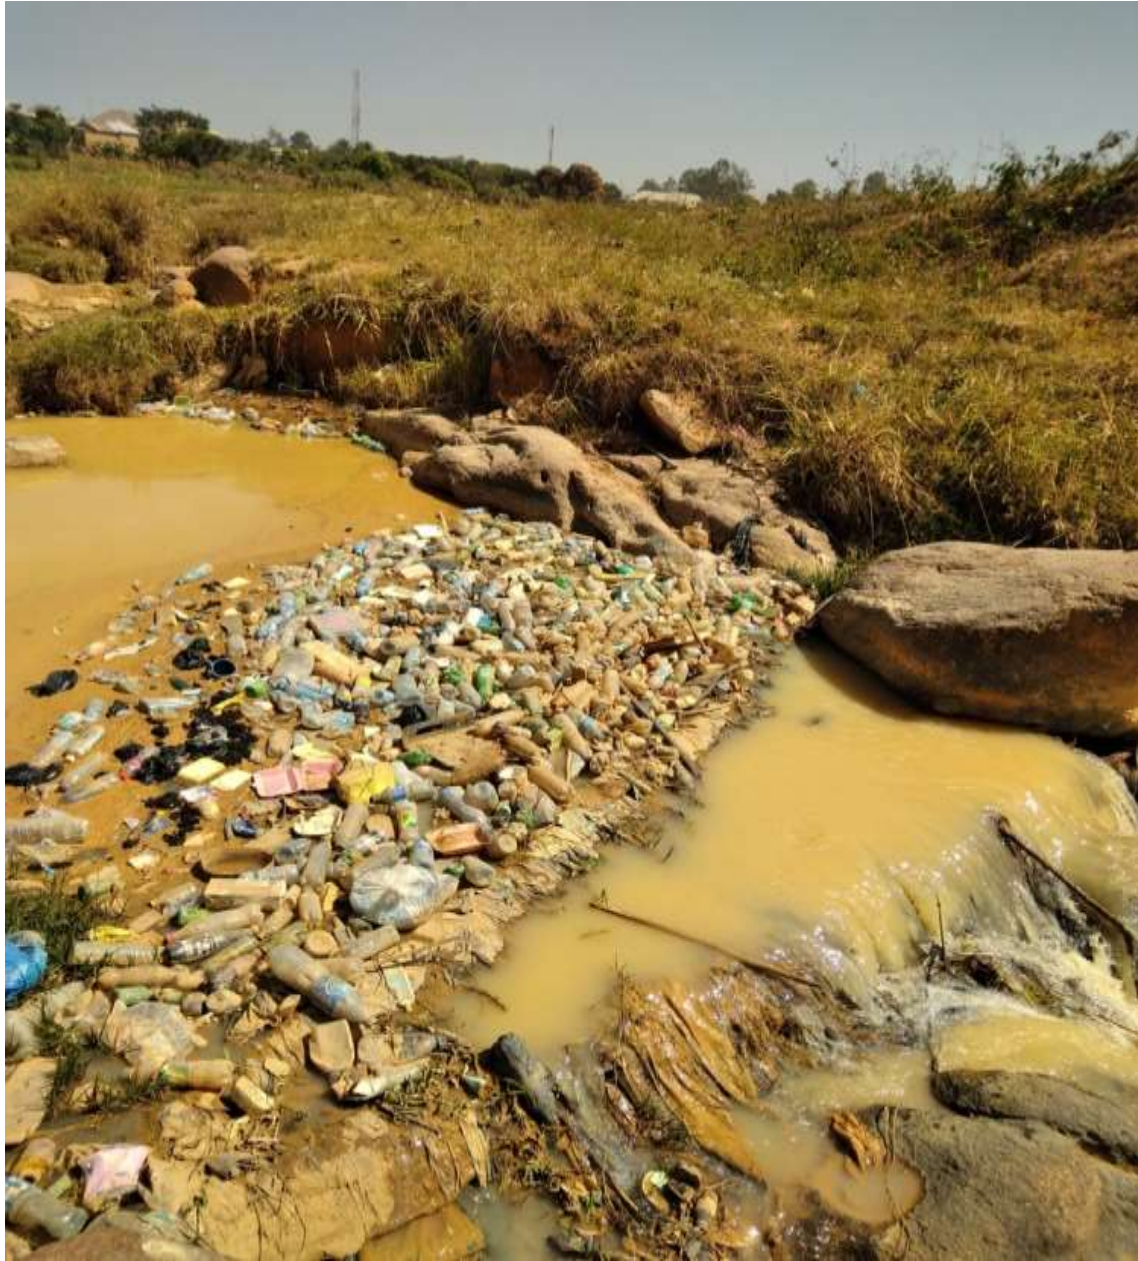
Plate 1. Plastic bottles, polyethene bags and rags within one of the Pyeng streams. Open defecation is a common practice along the channel.

- Pyeng community satisfy their water needs for domestic purposes from pipe borne water and individual motorised boreholes and hand dug wells.
- Because of the locations of the streams, they have been used by the communities as waste dump, open defecation sites and their waters are being used for irrigation activities. Coliform counts in the waters are higher than what the WHO and the NSDWQ recommended probably due to rampant open defecation in some parts of the catchment.
- The cloudy nature of the water in the lower catchment has led to high *E.coli* concentration isolated from the waters compared to the upper and middle catchments. Also, cadmium and nickel are higher in the lower catchment than the middle; these probably may be the result of huge plastic materials and polyethene bags that have been dumped in the stream channel.

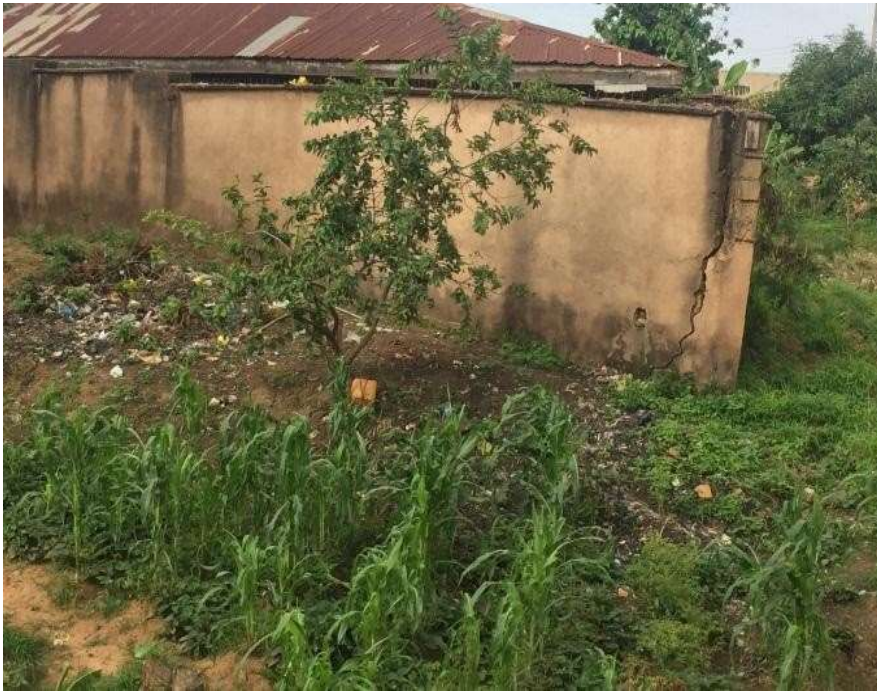
Plate 2. A building beside the open university at the verge of collapsing as a result of erosion

- The gullying observed beside the National Open University of Nigeria is as a result of stream bank erosion and back-cutting caused by the flowing water of a tributary of a major river. Some buildings were observed to be under threat from the erosion menace (Plate 2 and 3).

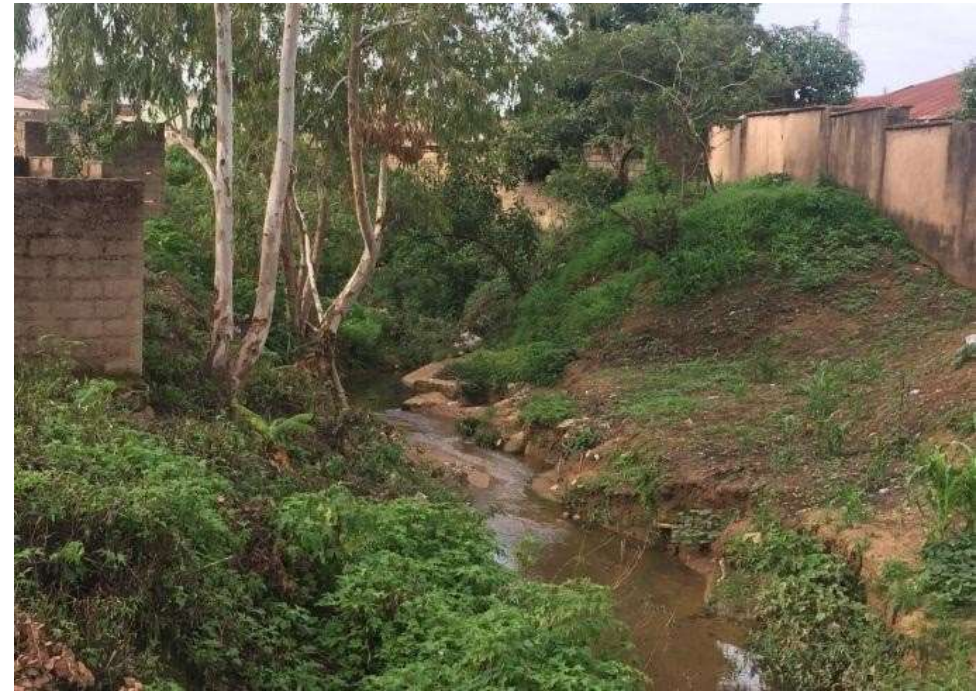
Plate 3. Buildings along a stream being threatened by erosion

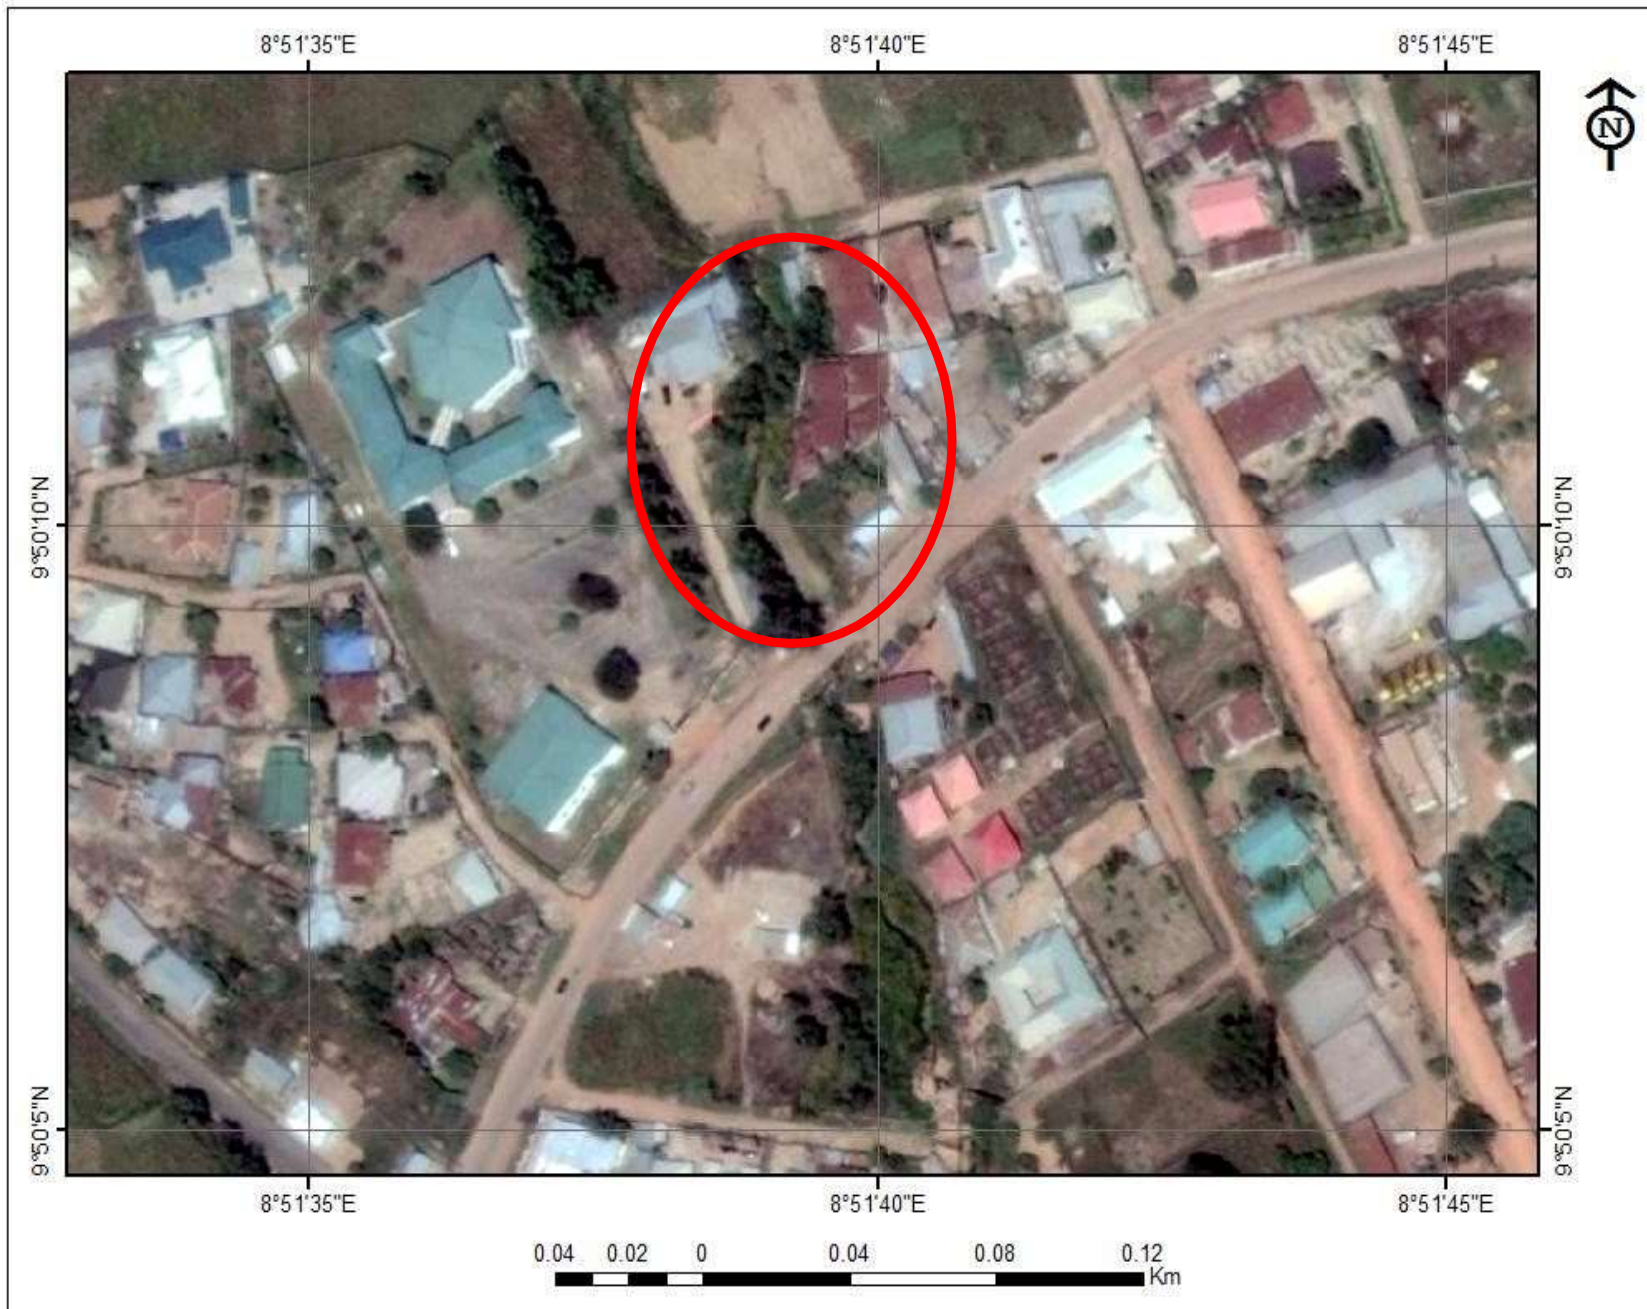
Figure 11. Satellite imagery of the area around the National Open University of Nigeria (erosion site is in red circle)
